Applies To: **1990–1993 Accord L4 – ALL**
1997–2001 Prelude – ALL

Hesitation or Stumble With Possible DTC(s) P0141, P0171, P0300, P0301, P0302, P0303, P0304, P0401, or P1491

(Supersedes 98-074, *Hesitation or Stumble*, dated December 8, 1998, to update the information marked by the black bars)

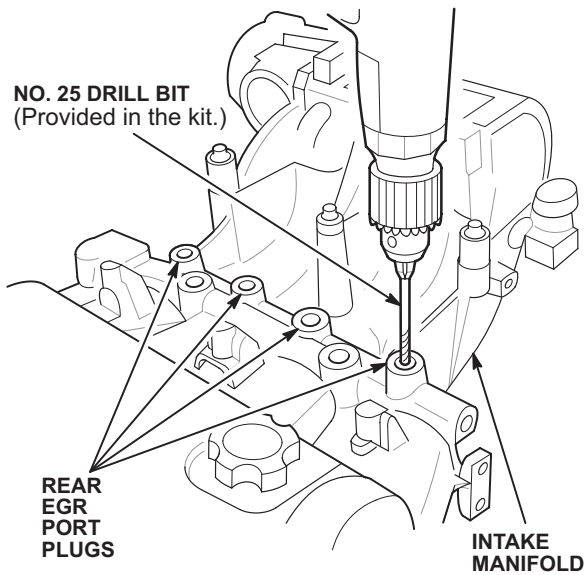
Carbon build-up may be restricting the EGR ports in the intake manifold runners.

1. If clearance is needed, remove the two mounting bolts for the electronic air control valve (EACV), then move the valve out of the way.
2. Remove the two mounting bolts for the fast idle valve, then move the valve out of the way.
3. Center-punch one of the rear EGR port plugs. Using the No. 25 drill bit from the EGR Plug Replacement Kit and a drill, make a hole in the center of the plug. Use a vacuum cleaner to remove the metal shavings as you drill.
